Multiple Trauma: A Team Effort

David Gallant, RN, OTC, Portland, ME

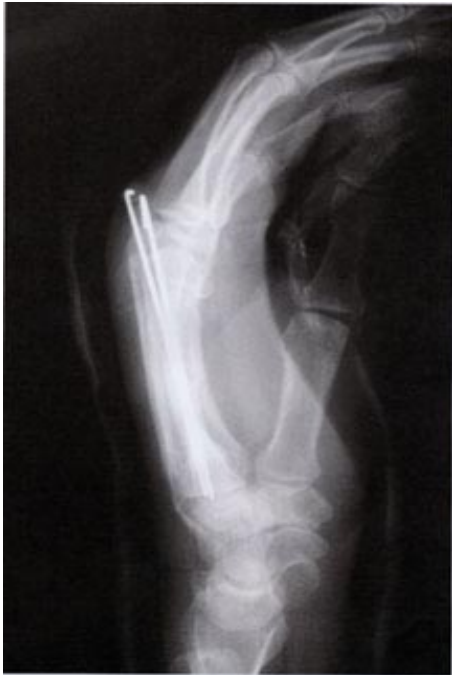
Photo 1

The metacarpal fracture was fixed with two percuta-

neous pins (see photos 1-2). The elbow fracture was fixed with two K-wires and Figure 8 circlage wires (see photos 3-4). The incisions were closed, the abrasions were covered with "non-adherent" dressings, and then the arm was immobilized: A fiberglass ulna gauntlet cast (UGC) was applied and then covered with a long arm fiberglass posterior splint.

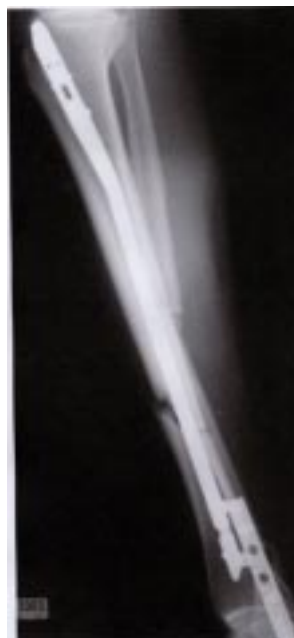
Photo 5

The tibia shaft fracture was fixed with a statically locked intramedullary rod, the distal fibula fracture was plated and screwed, (see photos 5-6), and following exploration and debridement, the foot injury was temporarily stabilized with screws and pins. Following dressing of the incisions and packing of the wounds, a short leg posterior splint was applied.

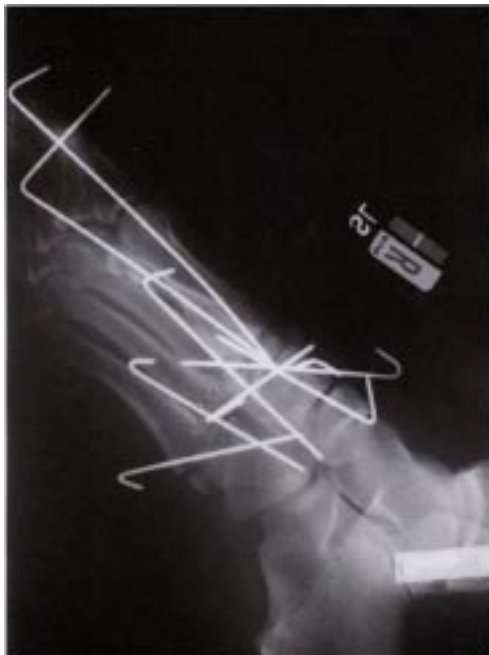
Photo 7

The medial wound was closed but the edges of the dorsal wound were necrotic requiring debridement and partial closure with stay sutures and loose approximation of the edges. All bones and tendons had skin coverage. The procedures necessitated the placement of nine (9) percutaneous pins (photos 7 - 8). The wounds were then covered with Adaptic and Xeroform followed by a bulky Jones dressing and plaster posterior and U-stirrup splint to the lower leg.

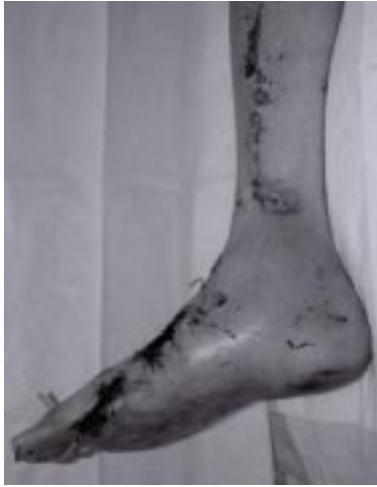
Photo 15

We removed the most recent post operative dressing and were frankly surprised to see that the poor lady's foot looked as if it had been attacked by a surgical porcupine (photos 14 - 15). After removing her previous surgery skin staples, we applied Mepitel and then dry sterile dressings to the wounds, scrapes, and abrasions covering the lower leg. Bulky padding was then applied over the pins in order to create a protective cavity that the foot would be placed into once the cast was finished.

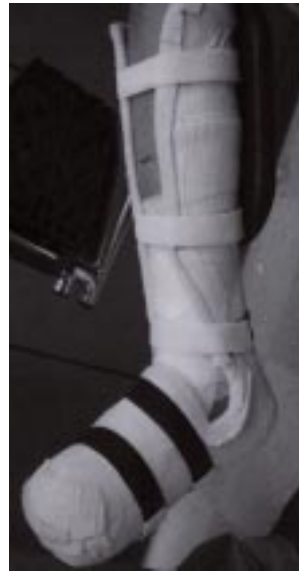
Photo 16

along the lateral side of the foot and around the tip of the toes to about midway on the medial side of the foot. A transverse cut from the lateral malleolus to the medial side of the foot was then made. This particular cut made it easier to remove the cast but still retained the toe cap as a big flap. I do it this way because I know how flexible the DCC is and how often caps or window hoods are lost in the great beyond (photos 16 - 17).

Applying this type of cast is not as difficult as it appears. First, I angled the cutting strip that is used in the technique, from the patella down over the shin, over the dorsum of the ankle, and down towards the little toe. A well laterally stretched length of Delta Terry Net "S" stockinet was then gently pulled (not rolled) onto the leg. Pre-cut pieces of Delta Terry-Net Adhesive Felt Liner were next applied over bony prominences and around the complete foot. While I was applying the padding, my colleagues were making the foot plate and stirrup out of 4" DCC which would add the structural support to the finished product. The struts were encircled by two rolls of 3" DCC. Once the material had hardened (about 5 minutes), I used scissors to cut from the proximal end down along the cutting edge,

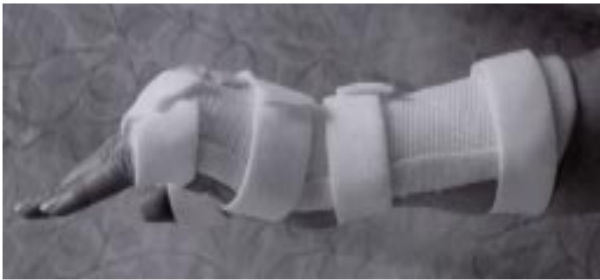
Photo 18

The pin removal went without incident and we placed her hand into a FRC dorsal splint with a ulna gauntlet and thumb extension(photos 18-20).

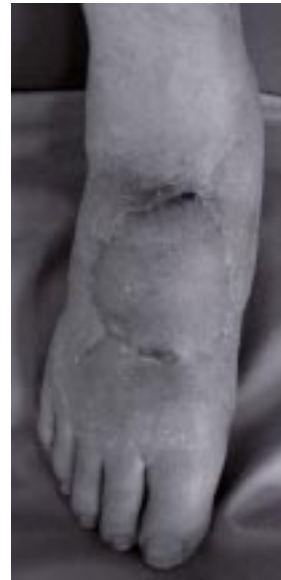
Photo 22

At seventeen weeks she began full weight bearing (with the boot in place) and her flap and graft site are healing quite well (photos 21-23). The prominent elbow hardware continued to be a problem for her thin arm (photo 24). So we fabricated a protective elbow pad of a style that we have found to be quite effective and practical⁴ (photo 25).
